SUBJECT: Historic Designation of England/Crown Farm Buildings

England-Crown Farm Building Assessment

9800 Fields Road
Gaithersburg, MD

CITY OF GAITHERSBURG – CROWN FARM BUILDING ASSESSMENT

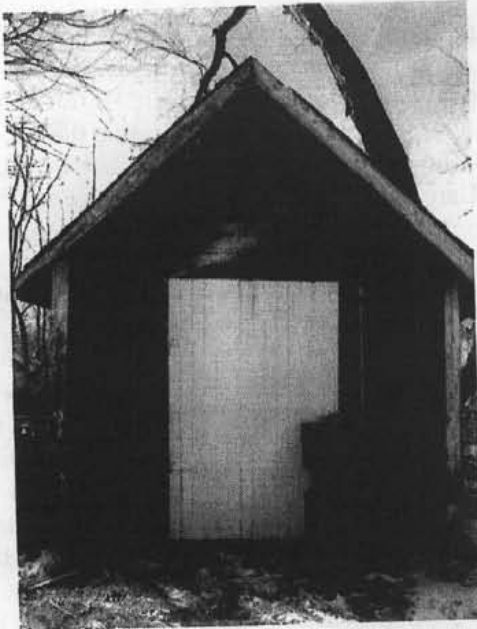
Building C (former Smoke House)

The building is in fair to poor condition and is in a state of neglect. Paint is peeling and there are areas of bare wood. There is evidence of moisture damage to the wood exterior sheathing especially near the concrete foundation. The gable roof has a great deal of moss growth on the shingles which indicate that there is excessive moisture. Several of the shingles at the

ridge and eave are loose and damaged. The door does not operate well and lacks proper hardware.

The interior of the structure is unpainted and moisture infiltration is apparent throughout, though the frame structure itself appears largely intact and in fair to good condition. The interior floor is concrete. There are several refrigerators or freezers in the structure and there is electric conduit and lighting noted. The building's most recent use must have been as a place to store frozen food. Its close proximity to the main house probably allowed easy accessibility to frozen foods for the residents of the main house (Building A)

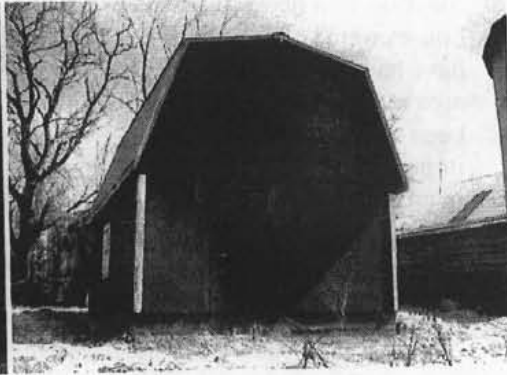
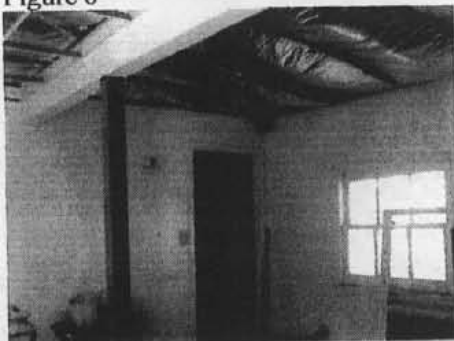
The building is in fair condition. It looks as if it were recently remodeled as the doors, several of the windows and steps are of recent construction materials. There is paint adhesion failure on all facades and there are patches of bare wood. There is evidence of moisture damage to areas of the wood exterior sheathing, at the corner posts, and at the roof cornice board. There is evidence of moss and biological growth at concrete foundation at the north side, indicative of moisture infiltration. The gambrel roof has rust streaks on both the north and south exposures.

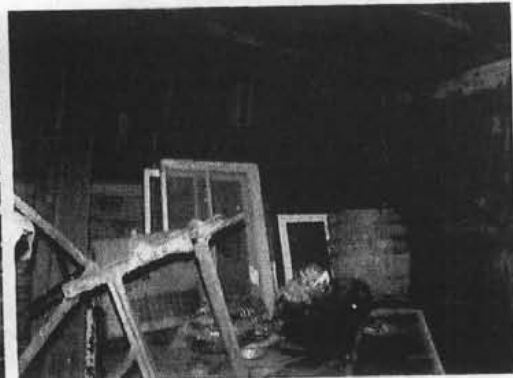
Figure 12

The buildings are in fair to poor condition and in a state of neglect. There is evidence of moisture damage at the exterior and the interior surfaces. The roof and wood roof framing structure are in fair condition but there are some moisture infiltration issues. The doors do not operate well and they lack proper hardware.

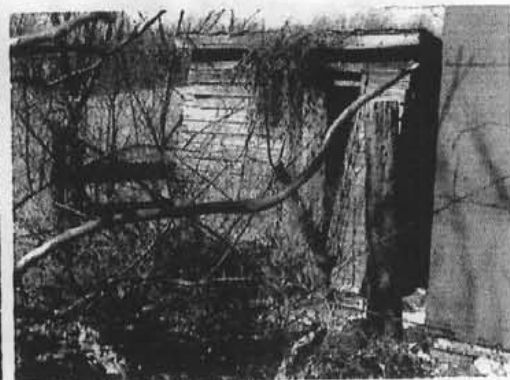
Figure 14

This building is in poor condition, in a state of neglect and disrepair. The framing of the shed is racking and leaning and the fasteners at horizontal planks are failing which has caused the siding to separate and has allowed weather penetration. There is moisture damage at the roof system. The door framing is racked and the door does not operate and lacks proper hardware.

There is no historic, cultural or architectural significance to this structure, however the existing wood materials that are in usable condition should be salvaged. This structure dates from the third period of construction ownership (See Sketch).

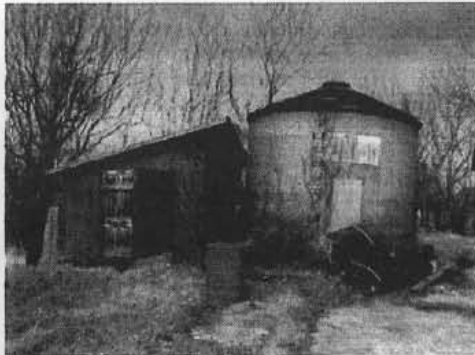
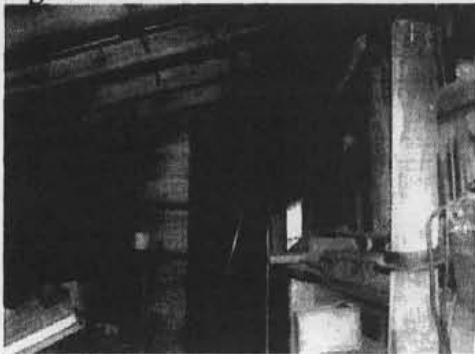
Building G (Shed)

The building is in fair to poor condition. There is evidence of some moisture damage at the exterior and the interior surfaces. There is paint adhesion failure on all facades and at the windows and there are patches of bare wood. There is evidence of moisture damage to the wood exterior sheathing, and at the roof cornice board. The interior framing of the walls and the roof is in fair to good condition as is the corrugated tin roof, which shows little to no sign of rusting.

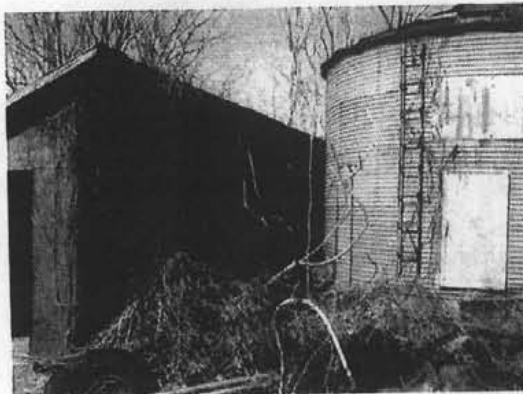
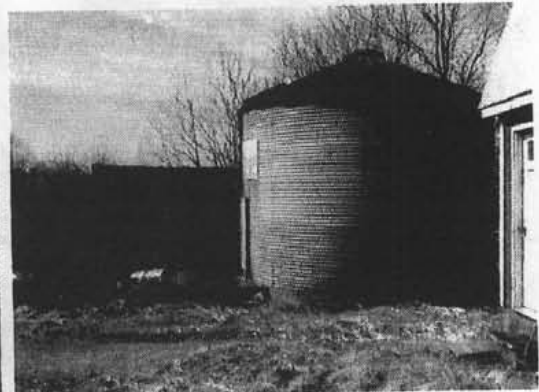
Building G/1 (Metal Corn Storage Bin adjacent to Building G)

The structure is in fair condition. It exhibits corrosion at all roof surfaces. The corrugated metal walls have signs of corrosion near the concrete pad base, at some metal surfaces and along some of the vertical seams due to rusting at the heads of the fasteners. The concrete pad is intact and also has rust staining and some minor cracking on the exterior surfaces.

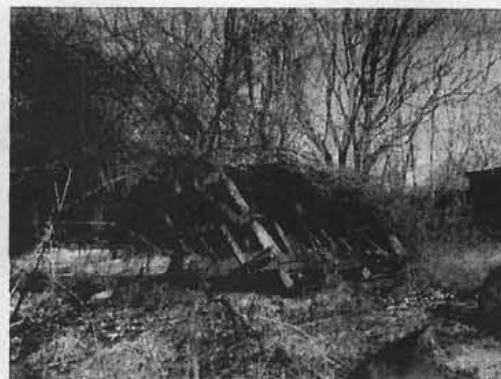
Figure 21

Building H was a one story wood framed shed, perhaps a small grain storage structure, in extreme disrepair. It has undergone complete structural failure and is no longer standing upright, but has collapsed. The timber frame was clad with wood planks which appeared to be placed to allow ventilation. It looked to have a gable metal roof. This shed looked to be rectangular in plan, about twelve by six feet is unpainted on the interior.

This building is in poor condition and is not at all usable in its present state.

This structure may have served as the corn crib prior to the more modern and larger metal grain storage building nearby. Its condition is beyond repair. There is no historic, cultural or

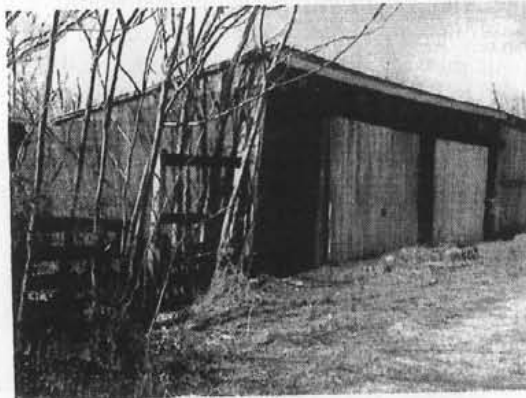
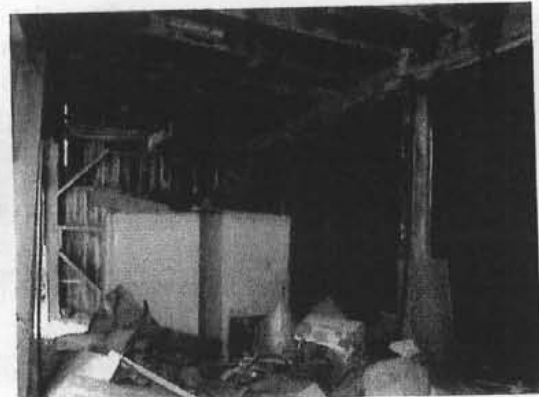
Figure 22 - Building I-1

Figure 23 - Building I-1

Building I-1 is in fair to poor condition and is in a state of neglect. Paint is peeling on all exterior facades and there are areas of bare wood and unpainted concrete block. Some of the concrete block, near the west side of the barn has open and failing mortar joints. A great deal of biological growth along the block indicates moisture infiltration which in turn is causing the bottom of the wood structure that rests atop the block to deteriorate. There is wood deterioration on the exterior throughout and many of the exterior wood cladding planks are loose and have failed fasteners. There is evidence of moisture infiltration at the interior wood surfaces especially along the outer walls and along the perimeter of the wood.

There is no historic, cultural or architectural significance to either of these structures; however the existing wood materials that are in usable condition should be salvaged. These structures date from the third period of construction ownership (See Sketch).

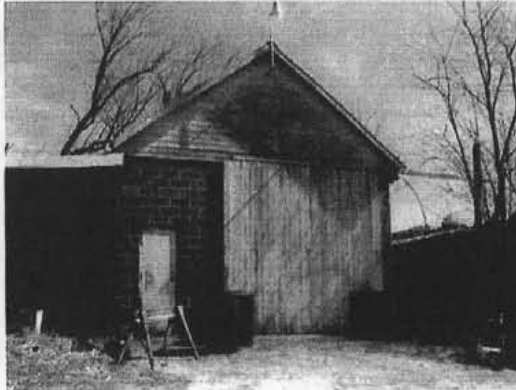
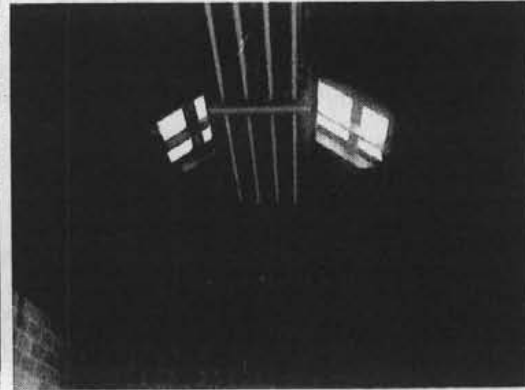
Buildings J (Garage/Storage) and J-1 (Storage)

The building is in good condition. There is some paint adhesion failure on the wood surfaces at the gable ends and at the wood and hollow metal doors. Some of the lower portions of the wood track door have some minor wood damage due to moisture. Some of the metal doors have signs of corrosion as well.

cover farm vehicles. It is in fair to good condition and the exterior wood surfaces need to be repainted.

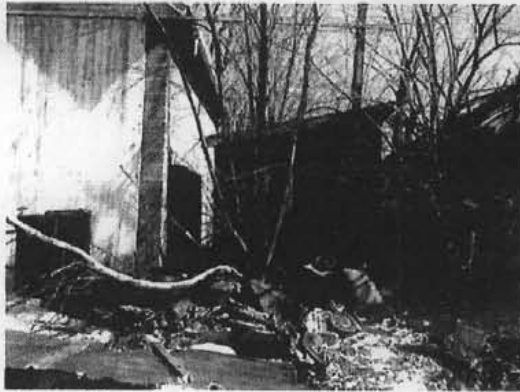
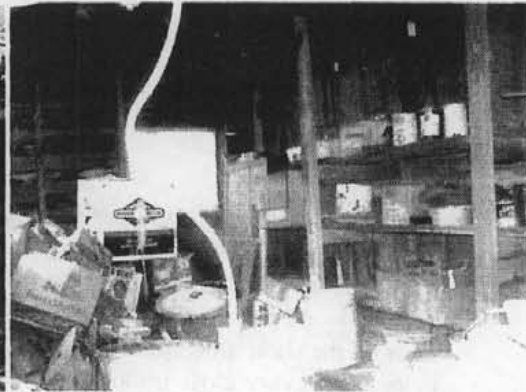
Building K (Storage Shed)

The building is in fair condition. There is evidence of some moisture damage at the exterior and the interior surfaces, especially at the inside roof sheathing. There is paint adhesion failure at the exterior wood surfaces and door. Some of the lower portions of the wood sheathing have damage due to moisture. The roof and wood roof framing are in fair condition but there is moisture infiltration. There are several trees in proximity to the structure that in time will cause damage to the structure as their roots expand and grow.

There is no historic, cultural or architectural significance to this structure, however the existing wood materials that are in usable condition should be salvaged. This structure dates from the third period of construction ownership (See Sketch).

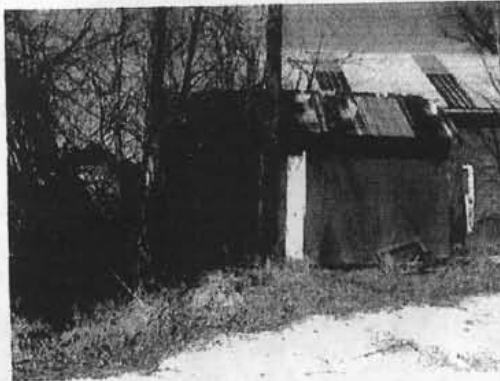
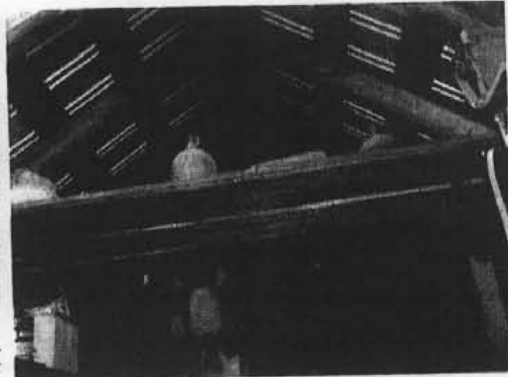
Building L (Storage Shed)

The building is in fair to poor condition. There is evidence of some moisture damage at the exterior and the interior surfaces. There is paint adhesion failure at the exterior wood surfaces and at the wood doors. Some of the lower portions of the wood exterior surfaces have some damage due to moisture. The exterior plywood sheathing is missing some fasteners and is loose in some areas. There is a great deal of corrosion on the exterior tin roof. At the interior, the roof and wood roof framing are in fair condition and there is some moisture infiltration. There are several trees in proximity to the structure that in time will cause damage to the structure as their roots expand and grow.

There is no historic, cultural or architectural significance to this structure, however the existing wood materials that are in usable condition should be salvaged. This structure dates from the third period of construction ownership (See Sketch).

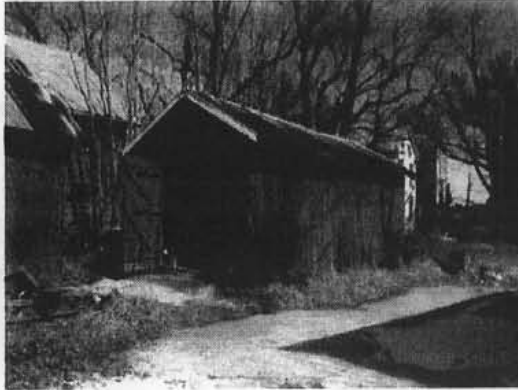
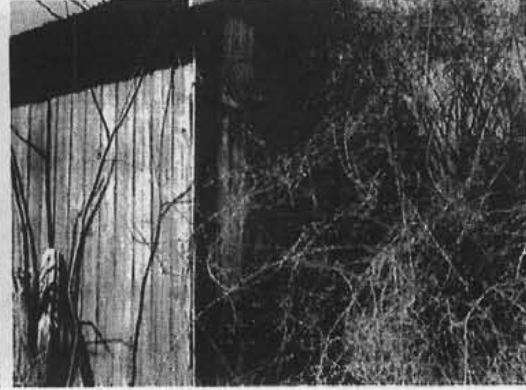
Building M (Cold Storage/Shed)

Building M is in fair to poor condition. There is evidence of moisture damage at the exterior wood surfaces. There is paint adhesion failure on the exterior wood surfaces and at the wood doors. The lower portions of the wood exterior surfaces have wood damage and deterioration due to moisture. The exterior sheathing is loose in many areas due to missing or failed fasteners. There is a great deal of corrosion on the exterior tin roof. There are trees and vegetation in close proximity to the structure that accelerate the damage occurring to the building.

There is no historic, cultural or architectural significance to this structure, however the existing wood materials that are in usable condition should be salvaged. This structure dates from the third period of construction ownership (See Sketch).

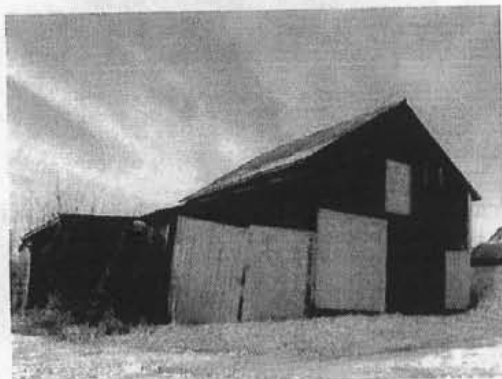
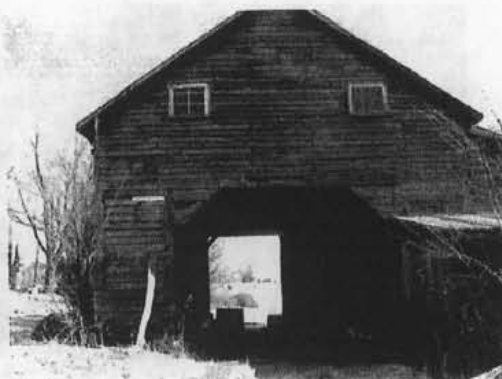
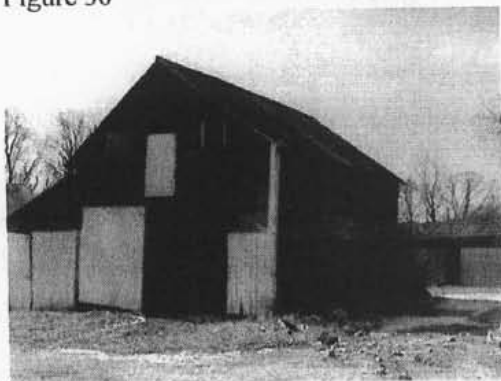
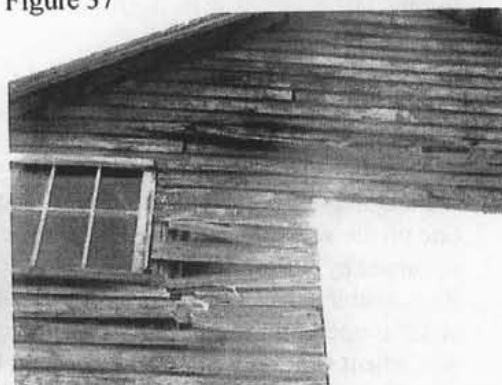
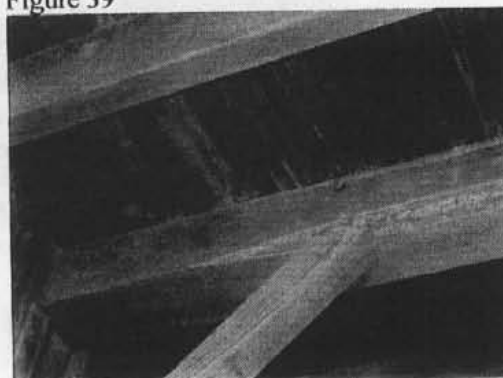
Building N (Corn Crib Barn)

Building N is in fair condition. At the exterior, paint is peeling and there are areas of bare wood. There is evidence of moisture damage to the wood exterior sheathing especially near the concrete foundation. There is some damage to the structural members at the second floor framing requiring repair. The stairs leading to the second level need to be reinforced as well. The exterior wood sheathing is in poor condition as there is noticeable deterioration and moisture damage. Some of the sheathing is loose due to failure of the fasteners. The roof has corrosion on the exterior face however, the interior surfaces do not show signs of corrosion.

employing mortise and tenon joinery, set atop a stone foundation base. The extent to which it should be preserved would be defined in a more detailed evaluation.

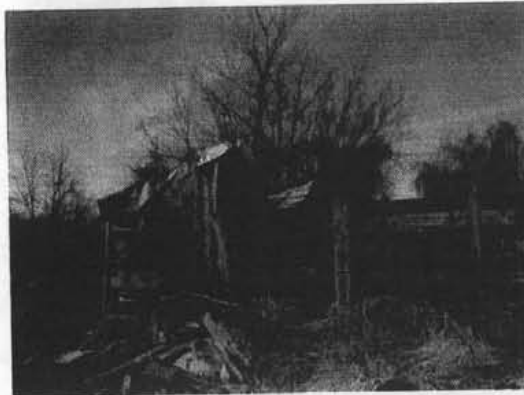
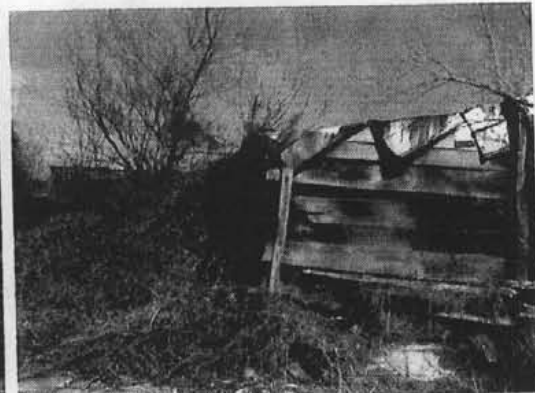
Building O (Shed).

This building is in poor condition, in a state of neglect and disrepair. The framing of the shed is racking and leaning. The fasteners at the horizontal planks are failing, causing the siding to separate and allowing weather penetration. There is moisture damage at the roof system and it has collapsed.

There is no historic, cultural or architectural significance to this structure, however the existing wood materials that are in usable condition should be salvaged. This structure dates from the third period of construction ownership (See Sketch).

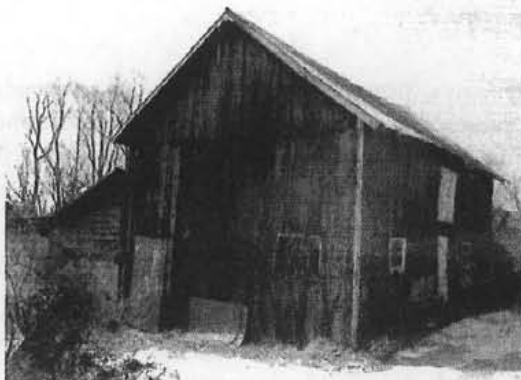
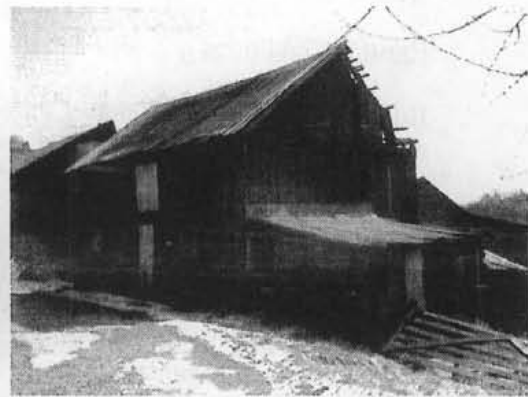
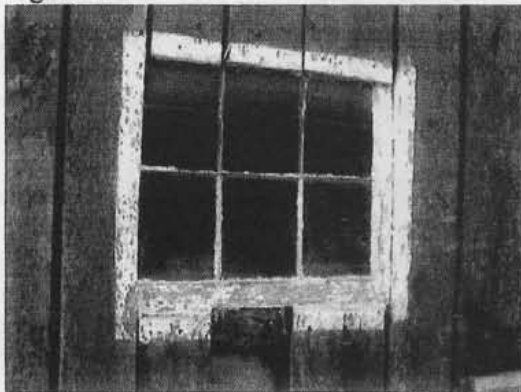
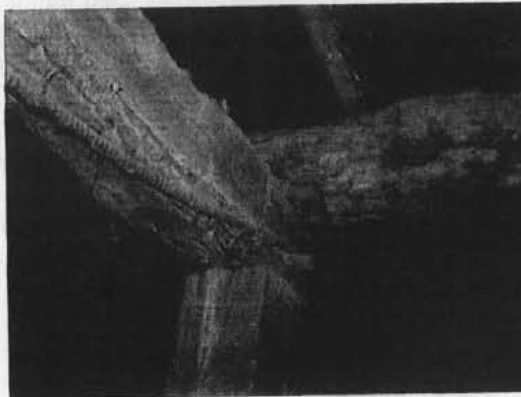
Building Q (Barn)

This building is in poor condition, in a state of neglect and is structurally unsound at the roof level. Paint is peeling and there are areas of bare wood on all elevations. There is evidence of moisture damage to the wood exterior sheathing especially near the foundation. The gable roof has excessive structural failure at the southwest end. Exterior sheathing is loose or missing and the roof framing at this area is open to the elements and it has deteriorated. This condition has also allowed for moisture damage to the wood elements within the barn. The doors do not operate well and they lack proper hardware. Corrosion has occurred at the exterior surface of the metal roof.

It is recommended that action be taken to stabilize the structurally unsound existing conditions so the further deterioration of this building is minimized. The extent to which this structure should be preserved would be defined in a more detailed evaluation.

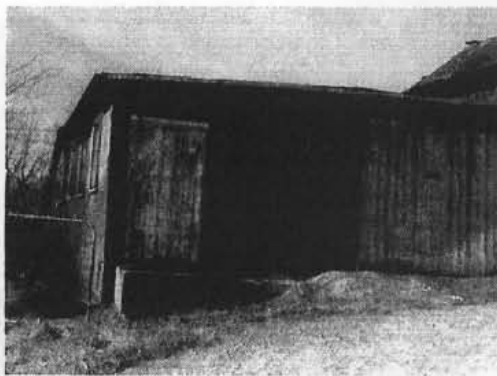
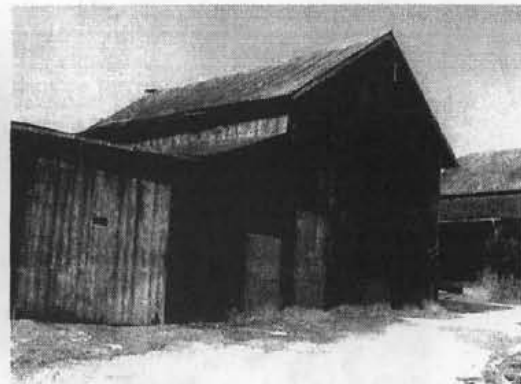
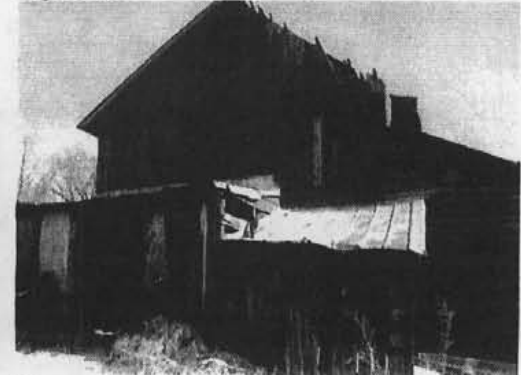
Buildings Q-1 thru Q-4 (Adjacent Shed and Storage Structures)

unpainted. The roofs are covered with galvanized metal. There are wood door which operate well and windows that do not. The windows lack proper hardware and are allowing moisture infiltration.

There is no historic, cultural or architectural significance to either of these structures; however the existing wood materials that are in usable condition should be salvaged. These structures date from the third period of construction ownership (See Sketch).
